CASE STUDY

Industry: Petrochemical

Cracked Cast Iron Bearing Housings

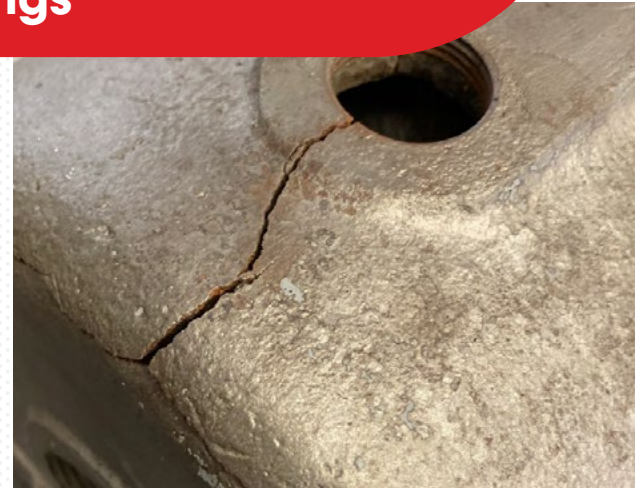
During a freeze event in Texas, a major refinery experienced failures of several bearing housings. The bearings were water cooled and when the plant lost power they also lost cooling water flow. The cast iron bearing housings cracked from water freezing in the housing. The entire refinery was shutdown due to the freeze event and several of the pumps with cracked bearing housings were required to restart the plant. The refinery required new or repaired bearing housings ASAP.

- Conhagen engineering was able to scan the existing bearing housings in 3-4 hours without delaying the pump overhaul.
- The pump bearing housings were repaired by brazing the cast iron as a temporary repair.

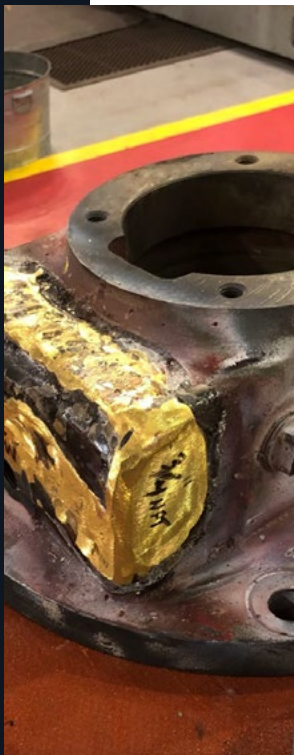
New Bearing Housing Style #1

Fabricated Water - Cooled Housing

The bearing housing was scanned prior to the temporary repair. Conhagen then fabricated a new carbon steel bearing housing. The new carbon steel construction is now weld repairable.

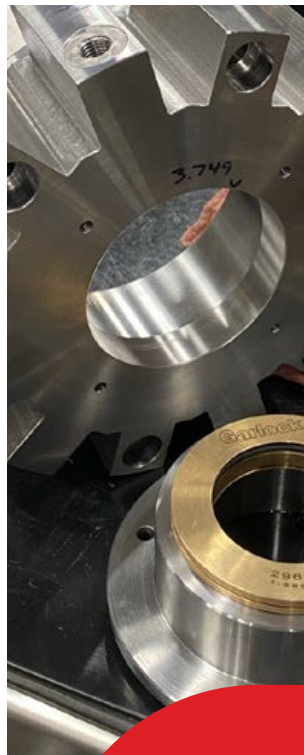
New Bearing Housing Style #2

Air - Cooled Housing

Conhagen engineering identified several of the frozen bearing housings could be re-designed to eliminate the cooling water entirely. The new housings are machined 410 steel and eliminate the failure mechanism entirely and still provide sufficient cooling to the bearing for reliable operation.
