Conhagen was brought in to resolve the steam turbine's erratic performance. The client's initial concerns centered on valve rack operations, but after reviewing the data, it was obvious that the issues extended beyond the valve rack.

## From Analysis to Execution: Comprehensive Steam Turbine Overhaul

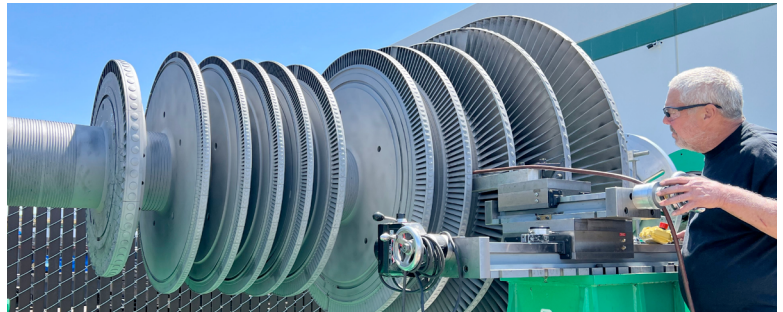
Upon removal of the valve rack, it was found to be obviously skewed. While the valve rack was being repaired, further investigation revealed that the U/H retainer blocks mechanically failed, and the last stage packing gland was found to be severely rubbed. This rub was a result of the L/H packing retainer hardware failing. The seal was nearly gone, the springs were not detectable, and the gland seal nor the box was reusable. The packing and gland box required reverse engineering and replacement as the plant did not carry spares for these items.

- The reverse engineering of the valve parts was completed. Production of 2 bushings, 2 stems, 2 valve seats, and a lift block were precision CNC machined, and nitride coated for the repair of the valve rack. These parts were then overnighted to the Conhagen CA shop for the final assembly of the valve rack.

- The LP gland seals and packing retainers required reverse engineering and were manufactured on an emergency basis. Multiple rows of packing seals were replaced, and a new retainer was designed and produced in less than 10 days. During the investigation of these failures, it was determined the diaphragm and packing retainer hardware were not adequate for this machine. All of these retainers & alignment blocks were re-designed and manufactured new.
