### CASE STUDY

Industry: Petrochemical / Power Generation

## Boiler Feed Pump Reliability Upgrade

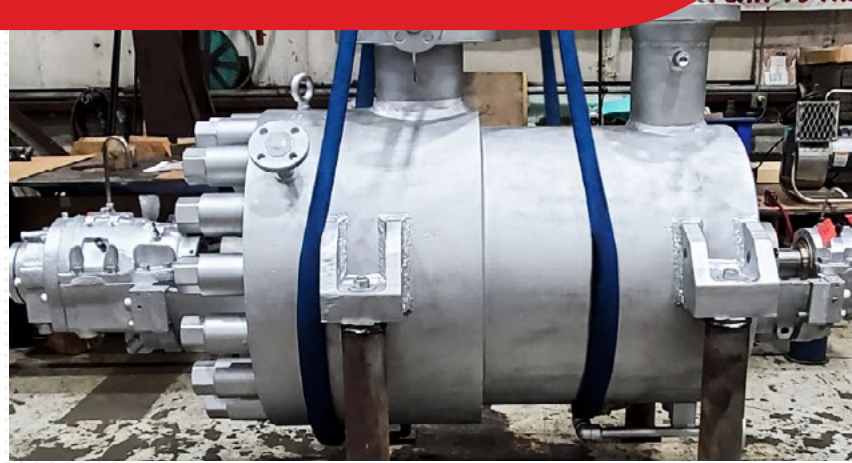
Historically these boiler feed water pumps have suffered from premature failures and reduced performance. Damaged balance drums or wear rings have led to failed bearings and impellers contacting the diffusers.

- Upgrade stationary eye seal material.
- Upgrade stationary impeller hub seal material.
- Mechanically lock the wear rings in place without the use of fasteners using Conhagen's clic-loc tongue & groove design.
- Add pressure reducing grooves to the high-pressure bushing for enhances rotodynamic stability.
- Install composite material in the balance drum assembly to allow for intermittent dry-running.
- Perform rotodynamic analysis to confirm compliance to API 610 stability requirements for the upgrade.

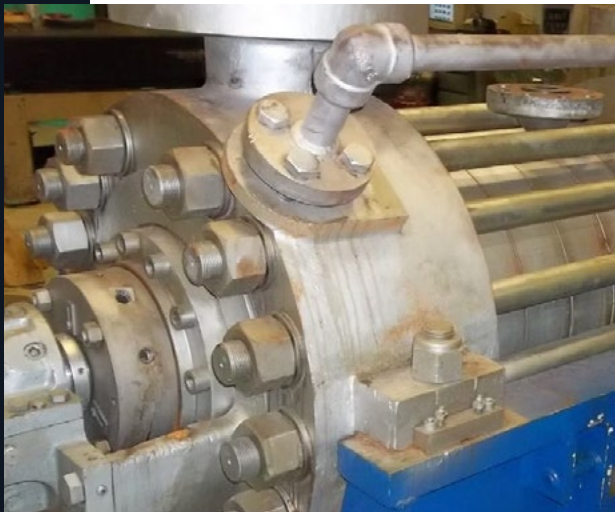
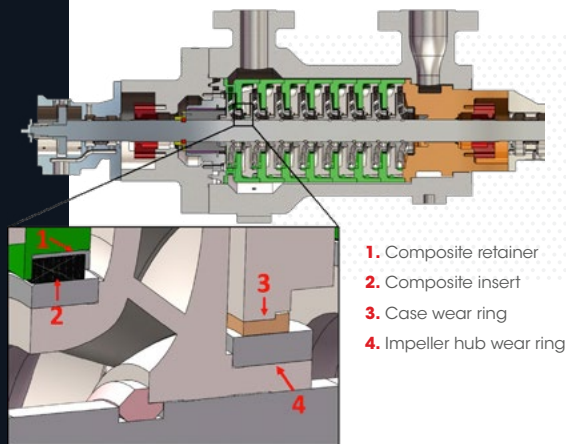
Conhagen has several of these upgrades installed across multiple customer sites, one of the early conversion pumps was pulled recently for scheduled overhaul after 12 years and wear rings were found to be in "like new" condition.

By upgrading to non-metallic rings the pump efficiency can be improved. The non-metallic wear rings allow tightening of ring clearances (50-75% of API) which improves pump efficiency. This upgrade can be easily applied during a scheduled overhaul, all the changes are internal to the pump components and will not affect any piping or auxiliary systems. Typically, this upgrade can be approved with a standard MOC process.
