CASE STUDY

Industry: Water Treatment

Golden State Warriors: Conhagen Strikes Gold in Pumping Perfection

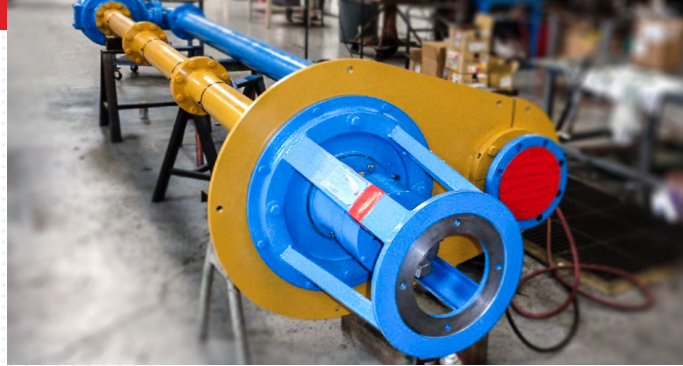
Eight new water treatment vertical sump pumps failed during the commissioning of a sewage treatment system that had to startup in eight days. Conhagen was tasked with redesigning the points of failure, installing the corrected pumps, and having them operable on a strict deadline.

Conhagen field crew removed and transported the pumps to our shop, where they were disassembled, cleaned, and all parts were inspected. Our inspection included identifying any measurements that were out of tolerance and performing PMI on all components to confirm their metallurgy. We also evaluated the design of any components that we deemed were related to the failure.

After our inspections, engineering determined that the bearing housings were inadequate for the application and redesigned them.

- Manufactured new shafts for all pumps
- Manufactured new upgraded/redesigned bearing housings from scratch
- Redesigned thrust bearing setups completely, including upgraded bearings
- Manufactured new spider bushings
- Machined fits on pump casings and pump covers
- Manufactured and installed new impeller wear rings
- Balanced impellers to 4W/N @3600 rpm
- Completely assembled pumps

Conhagen redesigned and fabricated eight new bearing housings. All affected pump components were cleaned and repaired. The pumps were then reassembled, tested, and installed at a rate of one pump per day. After all of the pumps were in place, we supported the testing of the entire system. We then took it up a notch by customizing the pumps with a paint job of royal blue and California golden yellow to match the Golden State Warriors' colors.
