CASE STUDY

Vessel Steam Turbine Vibration Reduction

A steam turbine generator onboard a container vessel was exhibiting high vibration. Conhagen was contracted to analyze and make recommendations.

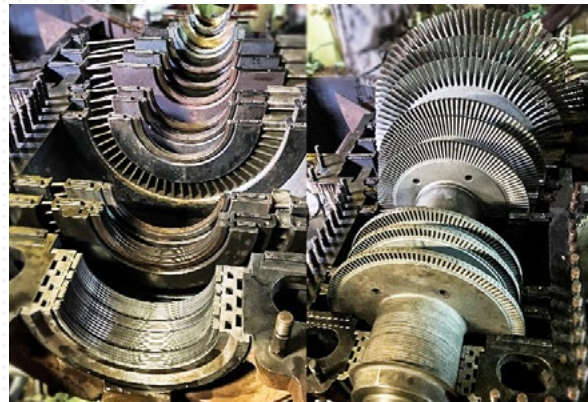
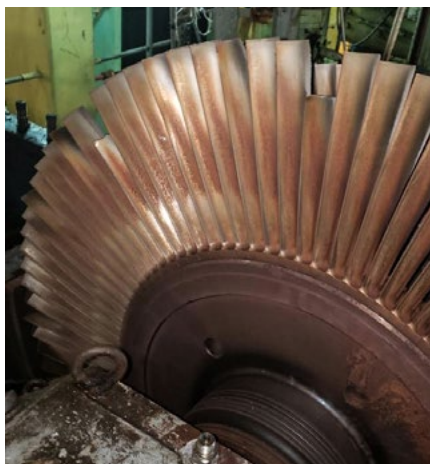
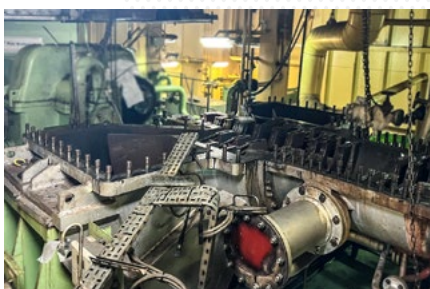
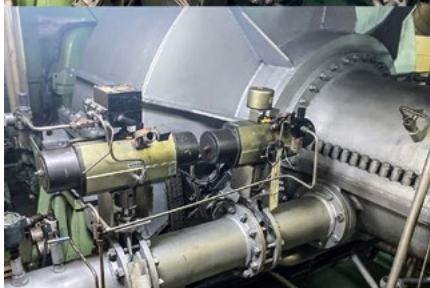
Conhagen engineering determined that the turbine casing should be removed and rotating elements be visually inspected. A Conhagen team boarded the vessel, removed the casing, and identified severe damage to multiple turbine blades.

The rotor was safely removed and taken to the Conhagen shop, where all repairs were made. The rotor was returned to the vessel and the turbine was returned to working condition by a Conhagen crew.

In addition to repairing the rotor, new bearings were installed along with all gland and diaphragm seal packing. Conhagen engineering and technicians were onboard the vessel while underway to the next port of call, supporting the commissioning and start up of the repaired steam turbine unit.
