CASE STUDY

Failed Crane Bearing & Housing Repair

Conhagen repaired a failed bearing and bearing housing on a paper mill crane over 120 feet in the air, preventing the disruption of normal production over Labor Day weekend.

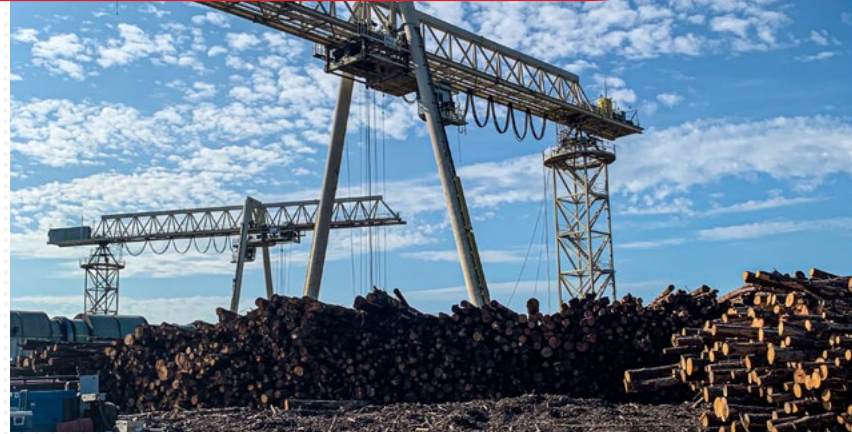
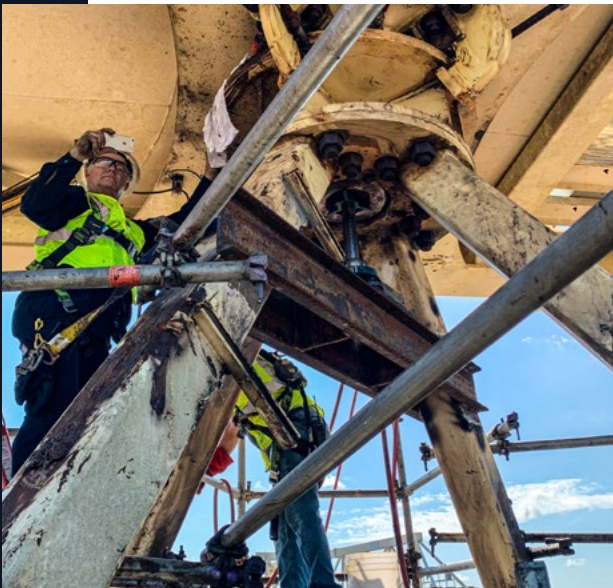
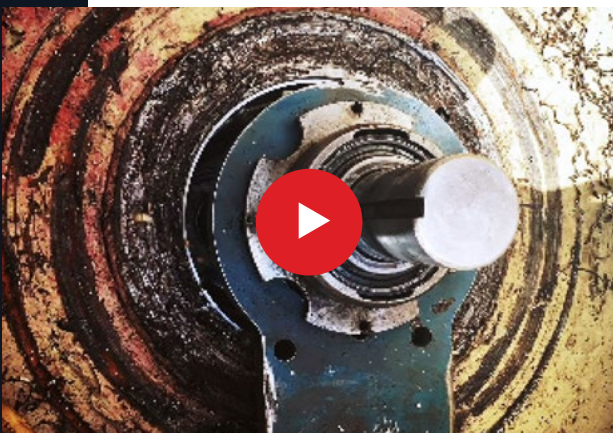
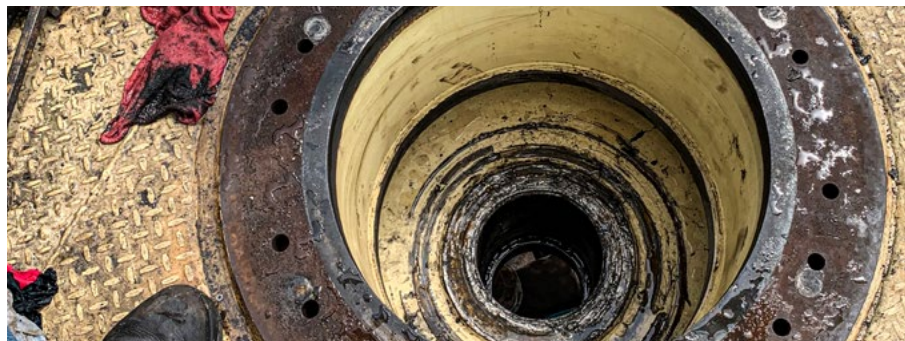
Repair a failed bearing and bearing housing on a paper mill crane over 120 feet in the air.

A field boring machine was set up to machine the housing in place. Simultaneously, Conhagen’s shop in Kenner, LA started manufacturing a sleeve that would be shipped to field for continuation of the repair.

With little advance notice, the Conhagen crew in both the shop and field worked through the Labor Day weekend to complete the repair before Labor Day. The crane is back in service and the mill did not experience a disruption in production.
