## CASE STUDY

Industry: Power Generation

# Comprehensive Overhaul of Cooling Tower Water Pump

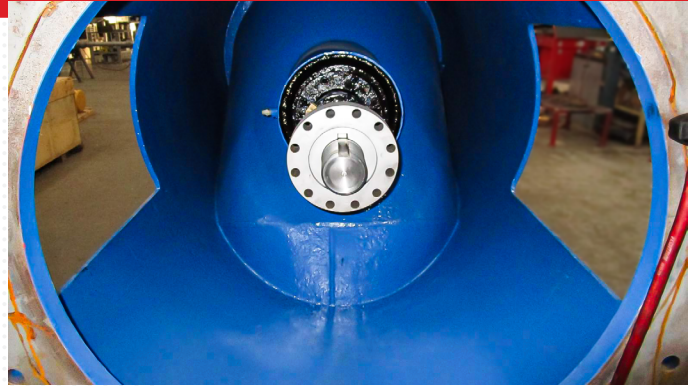
The primary objective was to restore the cooling tower water pump to optimal operating condition, ensuring minimal downtime for the energy plant. This required addressing the immediate issue of the snapped line coupling, which caused the pump shaft and impeller to drop onto the suction bell, resulting in significant damage. Additionally, the project focused on enhancing the pump's durability and performance while implementing long-term improvements to reduce future maintenance needs and costs.

- 3D Scanning, Reverse Engineering and Casting of a New Impeller.
- Manufacturing Shafts.
- Replacing Critical Bushings.
- Manufacturing and Installing a New Line Coupling.
- Applying a Two-Part Epoxy Coating.
