CASE STUDY

Industry: Petrochemical

Cracked Cast Iron Bearing Housings

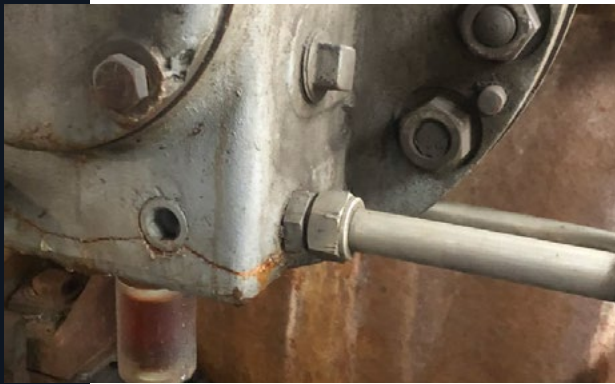
New Bearing Housing Style #2

Air - Cooled Housing

Conhagen engineering identified several of the frozen bearing housings could be re-designed to eliminate the cooling water entirely. The new housings are machined 410 steel and eliminate the failure mechanism entirely and still provide sufficient cooling to the bearing for reliable operation.
