Conhagen was brought in to resolve the steam turbine's erratic performance. The client's initial concerns centered on valve rack operations, but after reviewing the data, it was obvious that the issues extended beyond the valve rack.

## From Analysis to Execution: Comprehensive Steam Turbine Overhaul

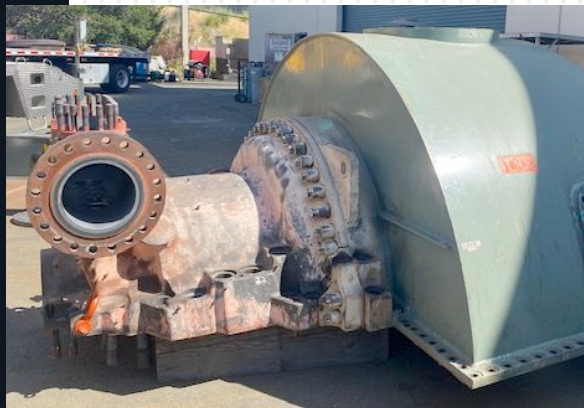
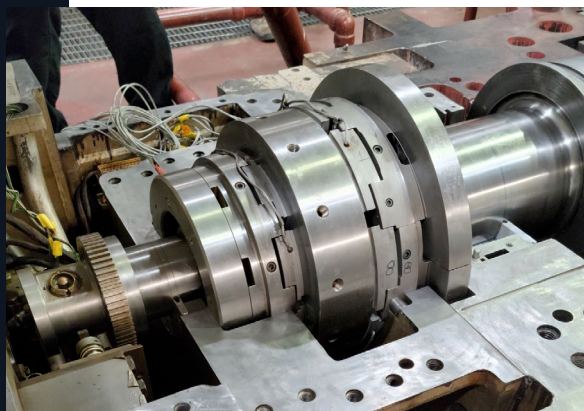
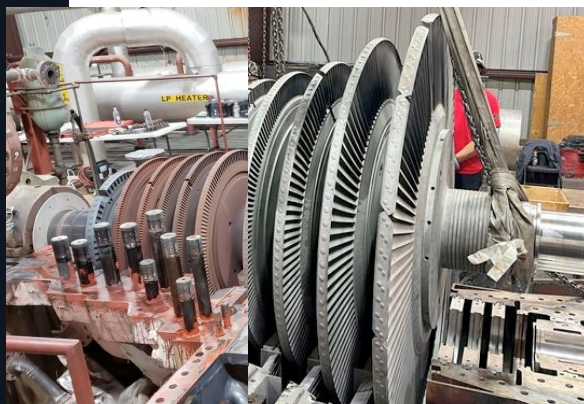
Upon removal of the valve rack, it was found to be obviously skewed. While the valve rack was being repaired, further investigation revealed that the U/H retainer blocks mechanically failed, and the last stage packing gland was found to be severely rubbed. This rub was a result of the L/H packing retainer hardware failing. The seal was nearly gone, the springs were not detectable, and the gland seal nor the box was reusable. The packing and gland box required reverse engineering and replacement as the plant did not carry spares for these items.

Our findings clearly indicated that a major inspection was warranted. The L/H diaphragms were removed from the unit, and the rotor, U/H case with diaphragms, and valve rack were all shipped to the Conhagen CA shop for inspections and repairs. The rotors and diaphragms were blast-cleaned and inspected. No significant issues were found beyond some areas of minor damage. The inlet side wheel transition radii of stg #7 & #8 were found to have erosion/undercutting. Conhagen smoothed and machined the radii removing the sharp edges/corners. Standard strap polishing of the remainder of the shaft areas was completed during this process.

- The reverse engineering of the valve parts was completed. Production of 2 bushings, 2 stems, 2 valve seats, and a lift block were precision CNC machined, and nitride coated for the repair of the valve rack. These parts were then overnighted to the Conhagen CA shop for the final assembly of the valve rack.

- The LP gland seals and packing retainers required reverse engineering and were manufactured on an emergency basis. Multiple rows of packing seals were replaced, and a new retainer was designed and produced in less than 10 days. During the investigation of these failures, it was determined the diaphragm and packing retainer hardware were not adequate for this machine. All of these retainers & alignment blocks were re-designed and manufactured new.
